MEMORANDUM

TO: Reclamation District No. 2028

SUBJECT: **March 2023 Engineer's Report**

HMP DEFICIENT SITES

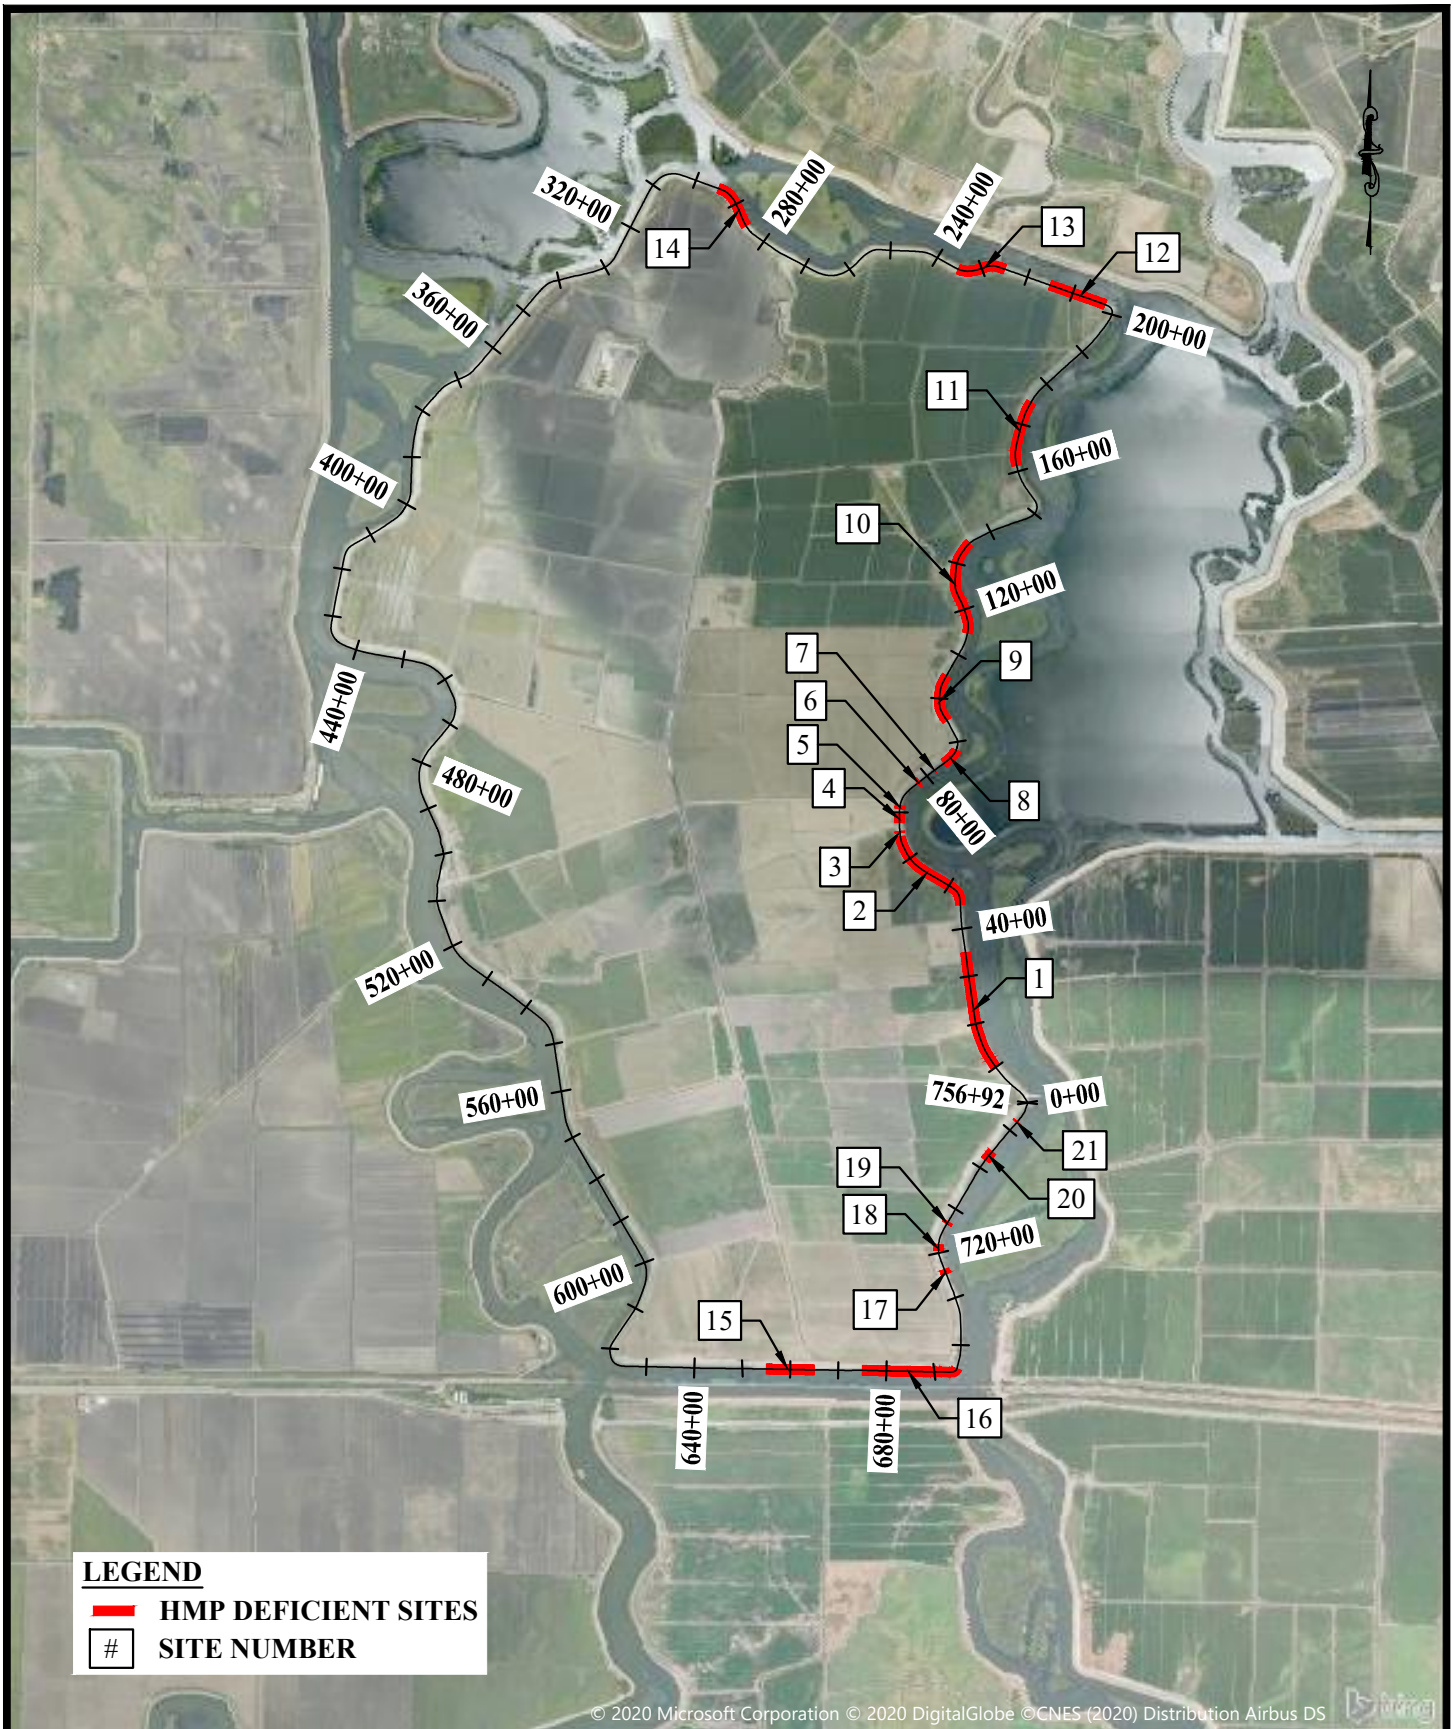
Annual Maintenance – Attached are the current maintenance items we are tracking. We have recently completed an updated survey of the levee system. Areas have been identified that have appeared to have settled, suggesting maintenance should be considered after the flood season.
